ORIGIN and CAUSE - Masonry Cracks

INVESTIGATIVE ENGINEERING SERVICES

Culp and Tanner, Inc.
Structural Engineers

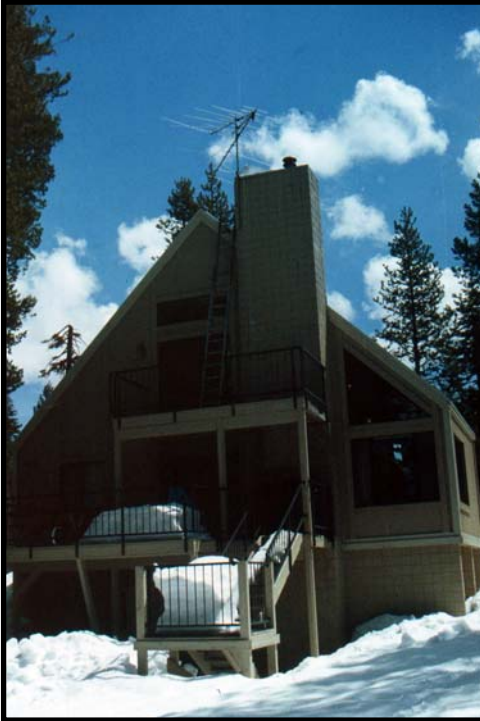
1. This home in Chester developed cracks in the masonry chimney.

The interior grout was soft and wet, it had never hardened due to a lack of cement. The moisture in the grout expanded when it froze, causing the cracks. When the chimney was torn down they found numerous other construction defects -- lack of reinforcing steel, paper stuffed in the masonry voids, etc.

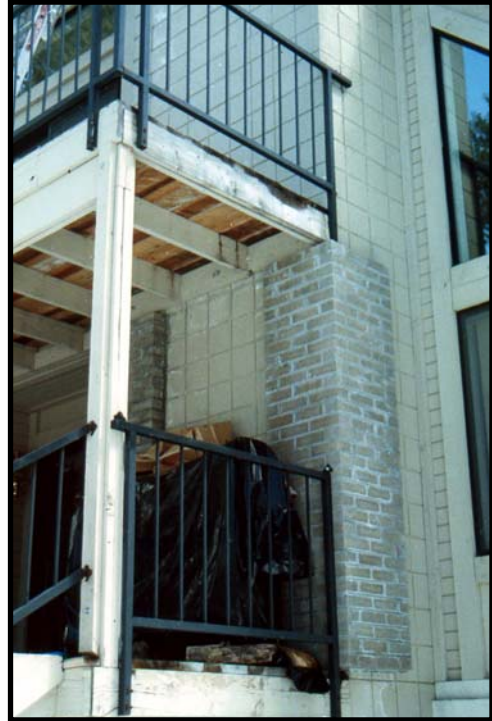
2. Originally the cracks developed in the lower portion, and the contractor "patched" them by covering them with a brick overlay.

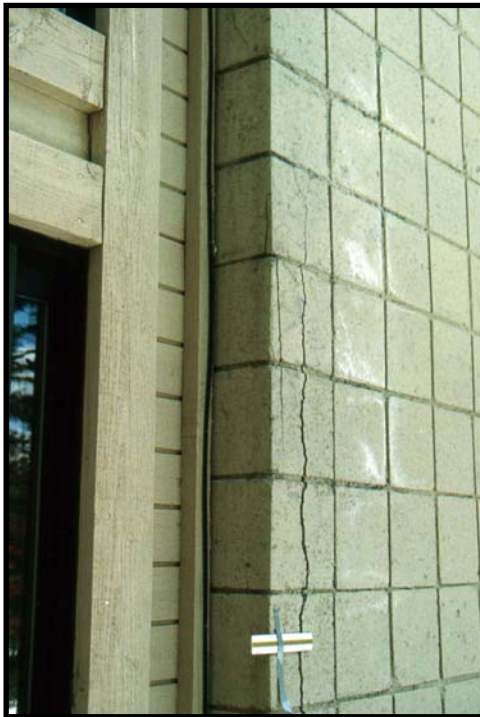
3. Subsequently, cracks also developed in the upper portion.

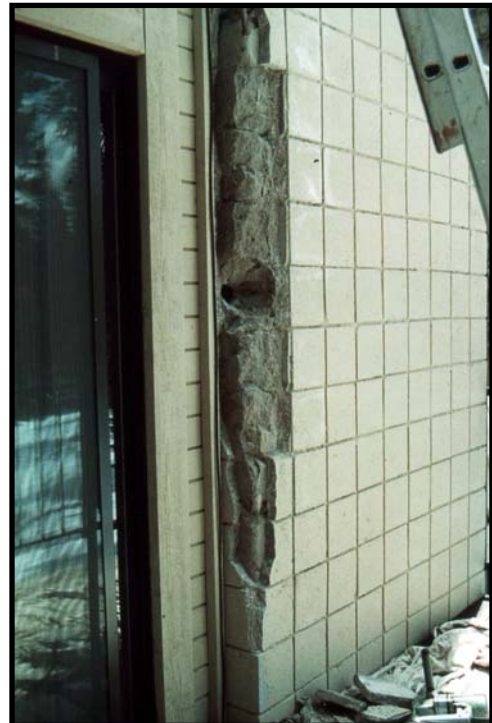
4. This entire piece came off with one blow from a chipping hammer.
