# ORIGIN and CAUSE - Retaining Wall Failure

INVESTIGATIVE ENGINEERING SERVICES

**Culp and Tanner, Inc.**

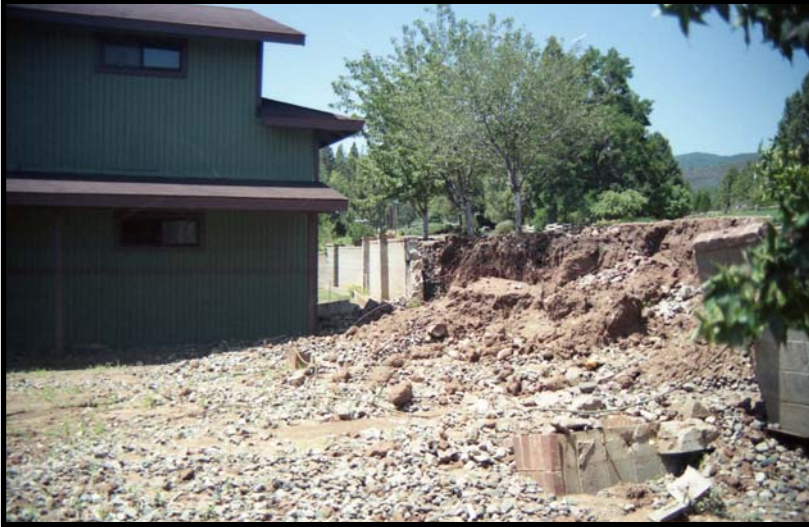
This masonry retaining wall failed after a major rainstorm.

Due to inadequate drainage at the base, water filled up the drainage rock section behind the wall, increasing the horizontal forces on the wall.

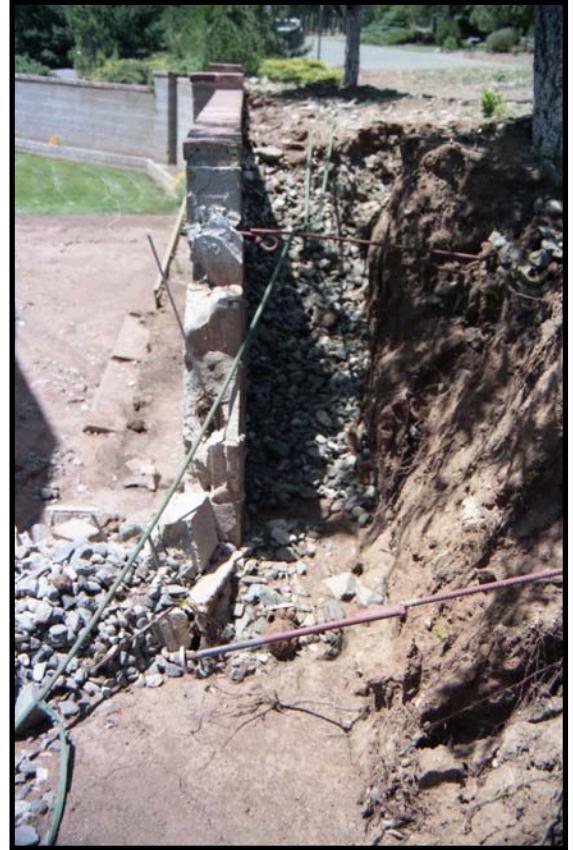
The top of this concrete footing should have had reinforcing bars doweling into the masonry wall above. The size of the footing was also found to be inadequate. Inadequate design coupled with inadequate drainage, caused this wall to fail.
