ORIGIN and CAUSE - Sheetrock Cracks

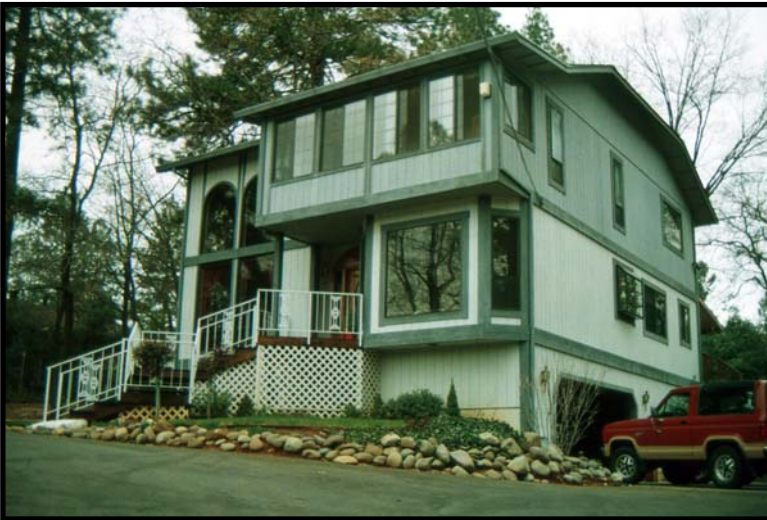
The garage on the lower level of this Paradise home was cut back into the hillside (left side of the photo).

The owner reported sheetrock cracks in the exterior wall and sloughing of the soils in the cut bank under the same wall.

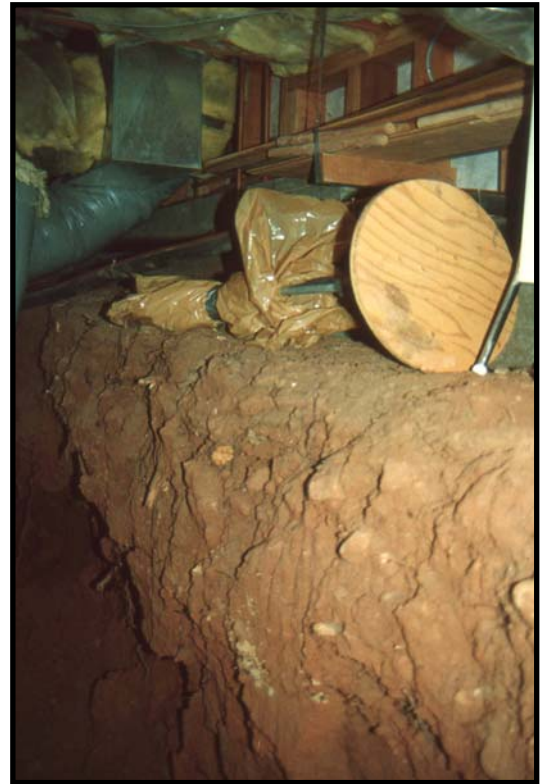
On site measurements showed the bank was cut too low under the exterior wall footing (the bottom of the cut should not have been below a 45 degree dashed line down from the bottom of the footing). Rain water draining off the hill behind the house was seeping under the footing and eroding out the cut bank, causing the wall to settle and crack the interior sheetrock.
