ORIGIN and CAUSE - Concrete Cracks

INVESTIGATIVE ENGINEERING SERVICES

Culp and Tanner, Inc.
Structural Engineers

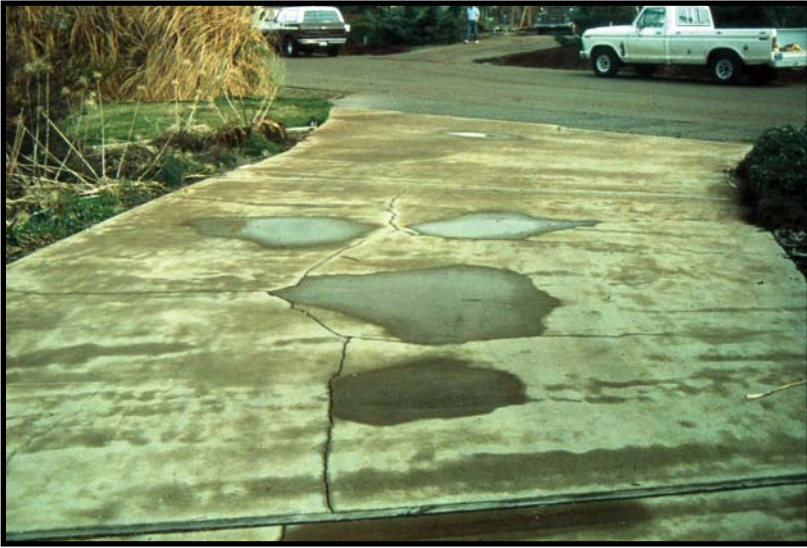
The homeowner of this driveway claimed heavy road construction equipment from a nearby road extension project used his driveway as a place to turn around, cracking his driveway.

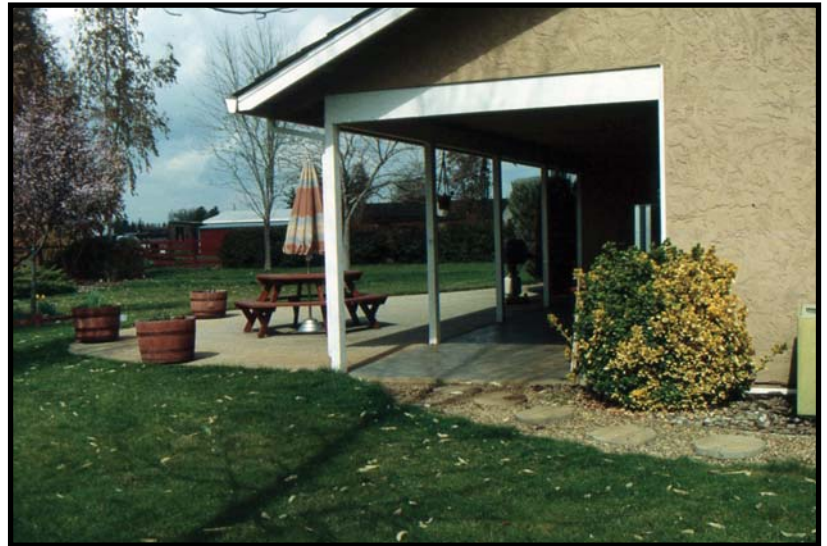
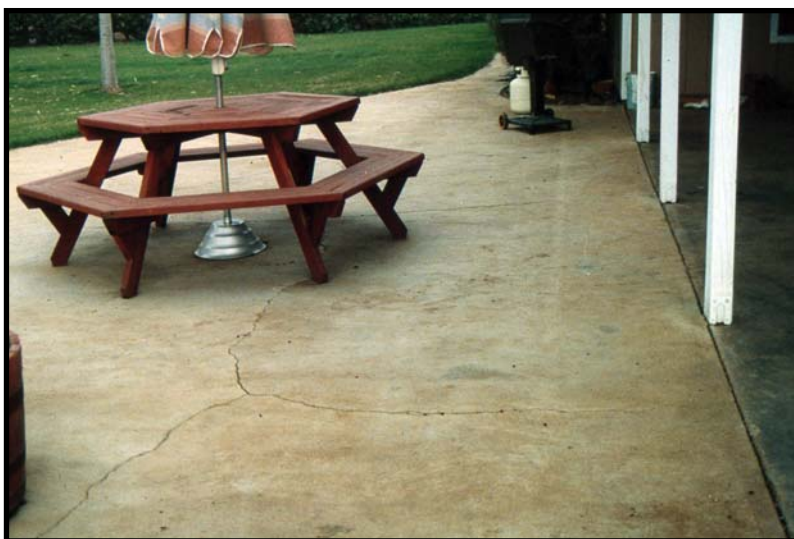
Side yard fences separated the backyard from the front of the house.

Since the backyard patio slab exhibited the same cracking as the front driveway, it was perplexing how the construction equipment got to the backyard patio without damaging the lawn or fences! Obviously the claim was denied.
