## **ORIGIN and CAUSE - Settlement**

INVESTIGATIVE ENGINEERING SERVICES Culp and Tanner, Inc. Structural Engineers

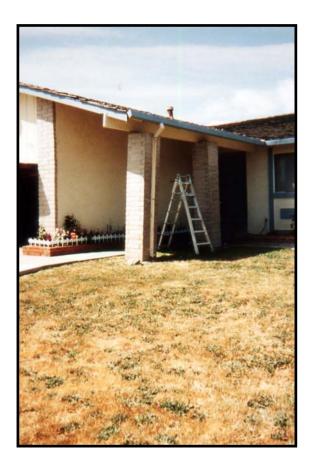
Not only were they leaning, but they had settled so far that they were no longer supporting the roof beam. This homeowner reported that his front masonry support piers were leaning.

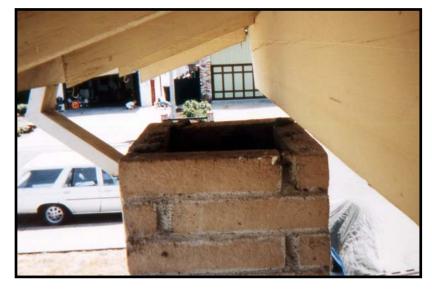
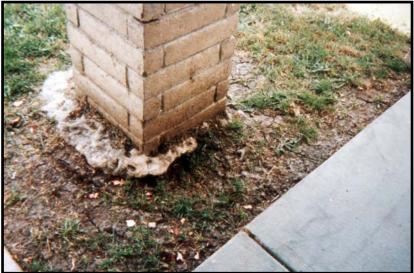
The cracks in the soils are a classical sign of clay soils, which shrink significantly when they dry out. The soils shrinkage cause the piers to settle and lean.
