# ORIGIN and CAUSE - Retaining Wall Failure

INVESTIGATIVE ENGINEERING SERVICES

**Culp and Tanner, Inc.**

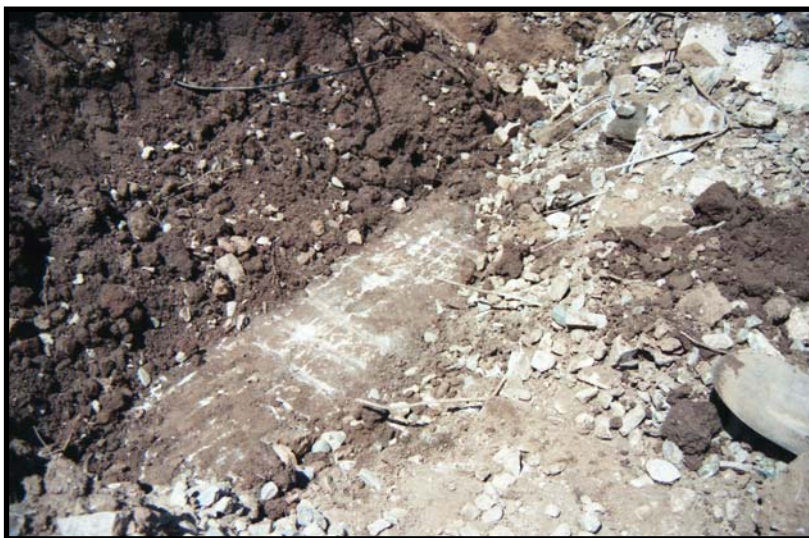
The top of this concrete footing should have had reinforcing bars doweling into the masonry wall above. The size of the footing was also found to be inadequate. Inadequate design coupled with inadequate drainage, caused this wall to fail.
