## Wes Hocking

Project Engineer / Director – Investigative Engineering Services Division

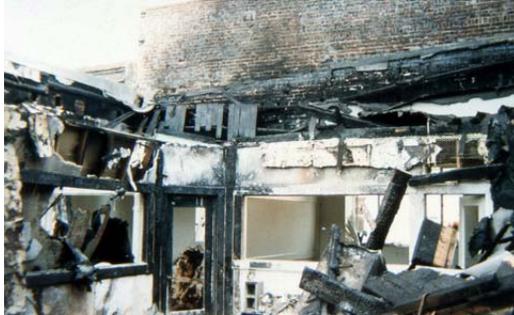
### Reconstruction

These losses include fire damage assessments, scope of repairs, collapse origin and cause, upcoding and betterment. This commercial fire in downtown Sacramento gutted a city block. Culp and Tanner's experience allowed the carrier to quickly conclude that the cost of repairs would exceed the policy limit, saving the carrier thousands of dollars in developing repair estimates.

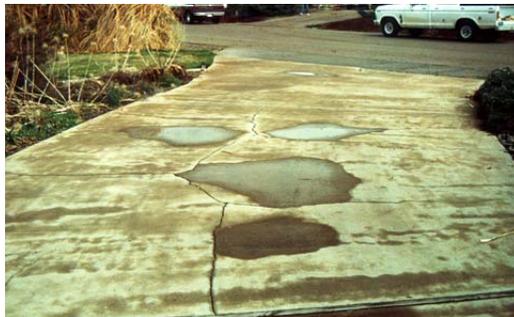
### Crack Evaluation and Remediation

Many claims deal with concrete or sheetrock cracking. Determination of cause is key is assessing coverage. This homeowner claimed heavy construction equipment from a road construction project drove on his driveway, causing the cracking. Since we found that the fenced in backyard patio exhibited the same cracks, it was easy to conclude the cracks were not related to the construction equipment.

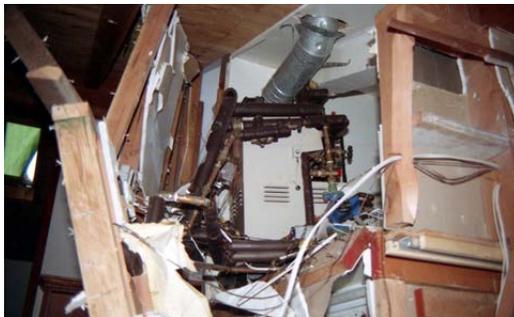
### Structural Damage Assessment and Scope of Repairs

A propane water heater in a huge custom home outside Santa Rosa exploded causing significant damage – blown out walls, windows, skylights, doors, etc. Originally the loss was estimated between \$350,000 and \$500,000. Our assessment showed mostly cosmetic damage, which led to a reduction of the actual loss by over \$100,000.

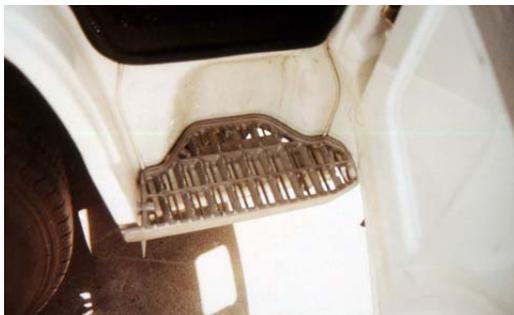
### Slip and Fall and Product Liability Investigations

Investigations of slip and fall, product failures and other liability claims. An individual claimed that this foot step on this rental truck was loose due to an untightened bolt, causing him to slip and injure himself. He said he retightened the bolt after his injury. Our investigation revealed that loosening any three of the five bolts holding the step in place would not cause the step to be loose.

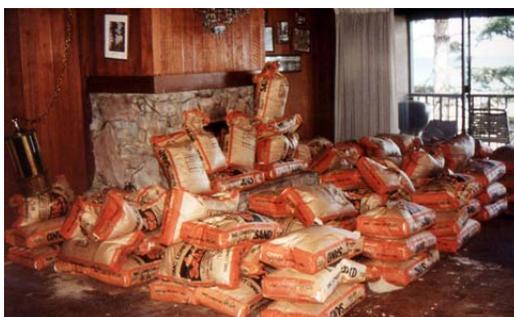
### Structural Integrity Assessments of Losses

Water from the firefighting of a chimney fire caused the floor and ceiling plywood to warp in this condominium overlooking Lake Tahoe. Since the plywood was an integral part of a special structural floor system, we load tested the floor using sand bags. We were able to demonstrate that the floor was still structurally sound, saving the carrier from having to replace the floor system.
